MARINE PILING INVESTIGATIONS

NATIONAL RESEARCH COUNCIL

MARINE STRUCTURES

THEIR DETERIORATION AND PRESERVATION

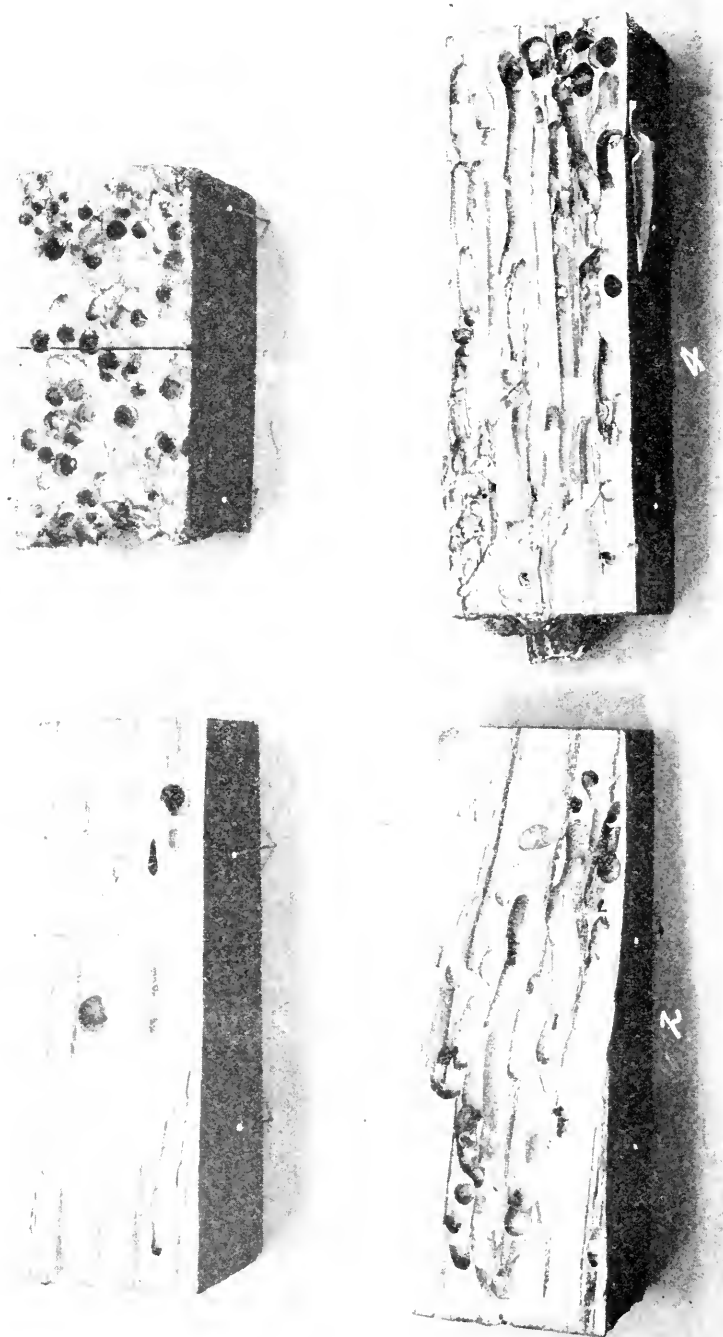
FIG. 4—SECTIONS OF BLOCKS FROM NEW YORK, NEW HAVEN & HARTFORD R.R. TEST BOARDS INSTALLED JUNE 1, 1922.

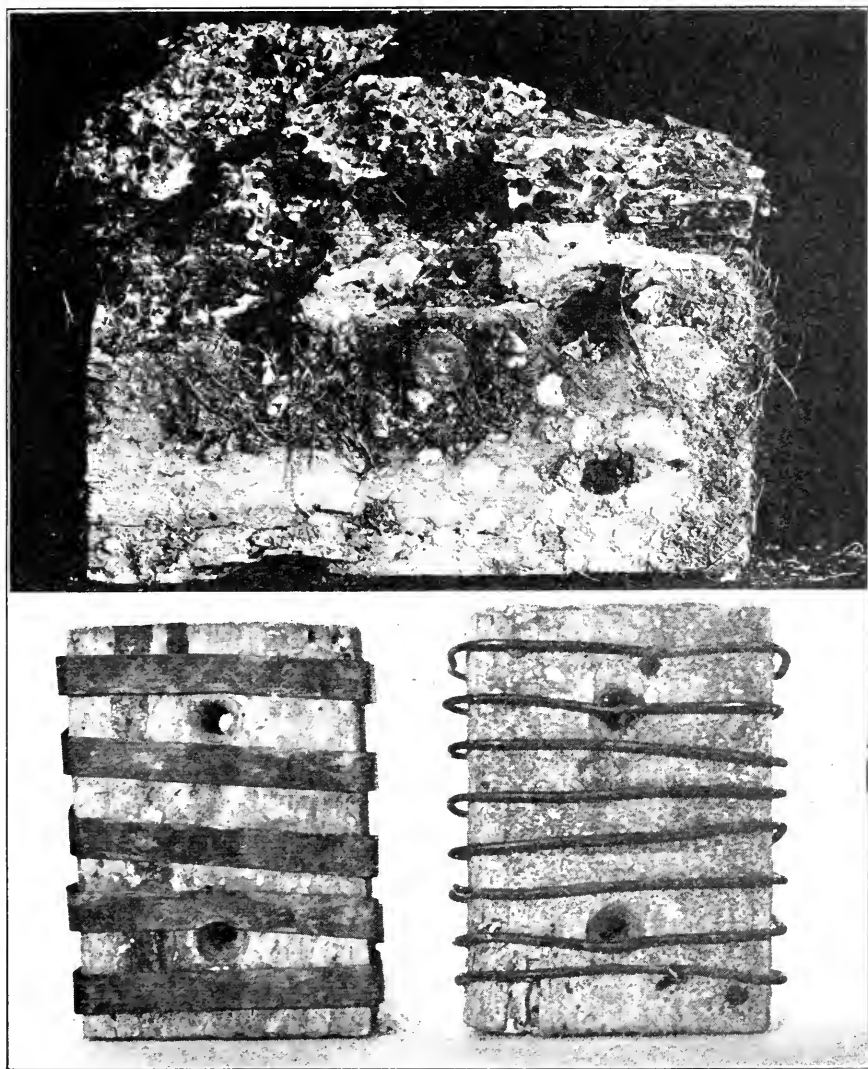
When these blocks were removed after this three months' period it was found that the copper had slowed up the destruction very appreciably (Fig. 6), and that the strips were more effective than the wire. The animals in both the bound blocks appeared to be dead, while those in the unbound block were many of them alive. On account of this encouraging result, eight test boards were prepared by the U. S. District Engineer at Charleston, S. C., and immersed at Castle Pinckney, where the attack was known to be heavy. These blocks were bound with $\frac{1}{2}$ -in. copper strips and with wire spaced from $\frac{1}{2}$ in. to $2\frac{1}{4}$ in., varying by $\frac{1}{4}$ in., with every third block unprotected as a control. Seven sets of blocks were mounted on galvanized bars and the eighth on a palmetto pole. The blocks from these boards were removed periodically as in the case of the standard boards.

FIG. 6.—TESTS OF COPPER WIRE AND BANDS, CHARLESTON, S. C.
BOARD SUBMERGED SEPTEMBER 6, 1922

It would therefore appear that the copper strips 1 in. apart, while they caused a much less intense attack, did not give ultimate protection.

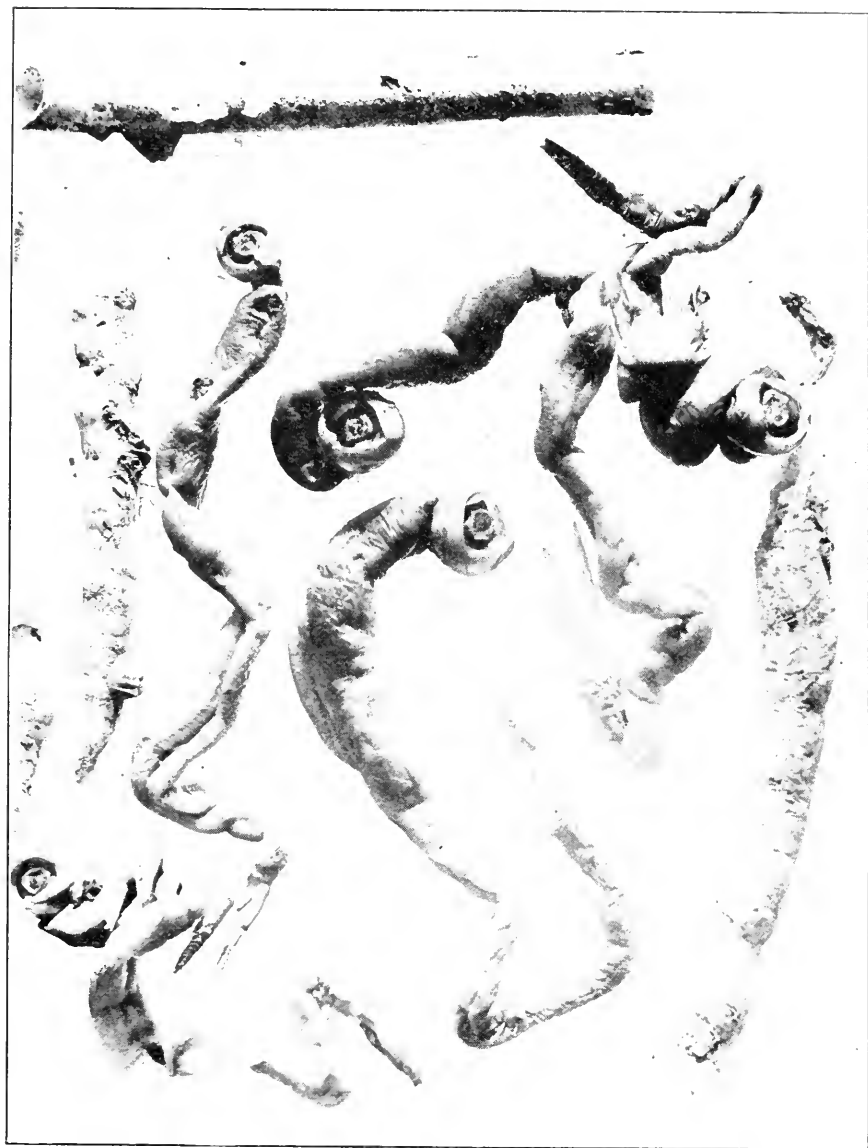
FIG. 15—SPECIMENS OF *Bankia* REMOVED FROM BURROWS WITH SECTIONS OF THE BURROW CASINGS.

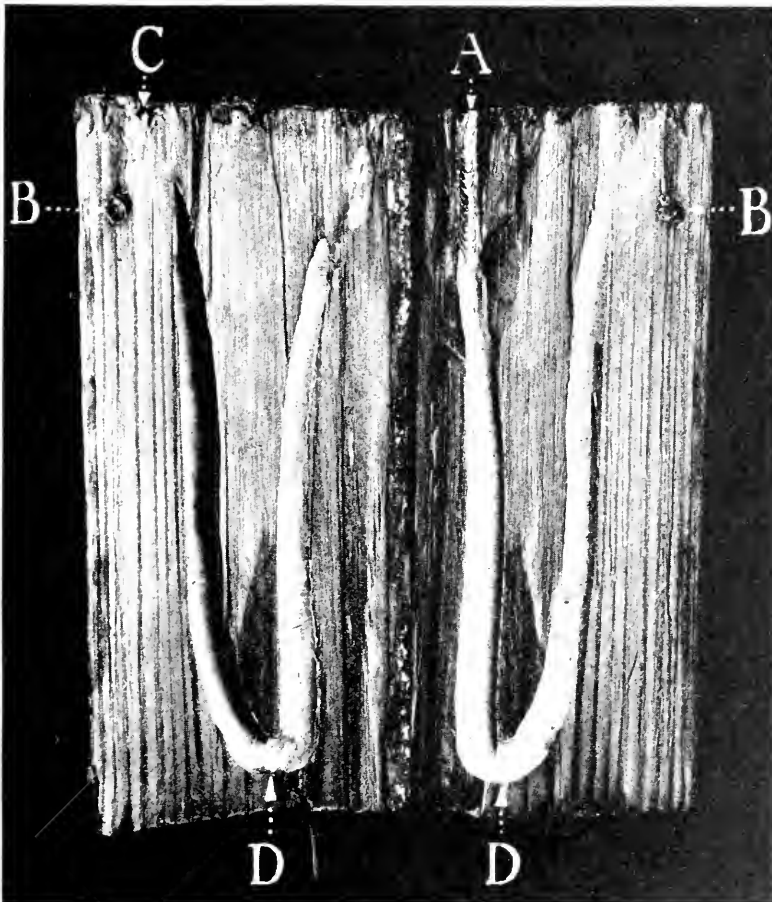
FIG. 16—*Bankia setacea* 12 INCHES LONG IN TEST BLOCK FROM COOS BAY, ORE. BLOCK PLACED JUNE, 1921; REMOVED OCTOBER, 1922.

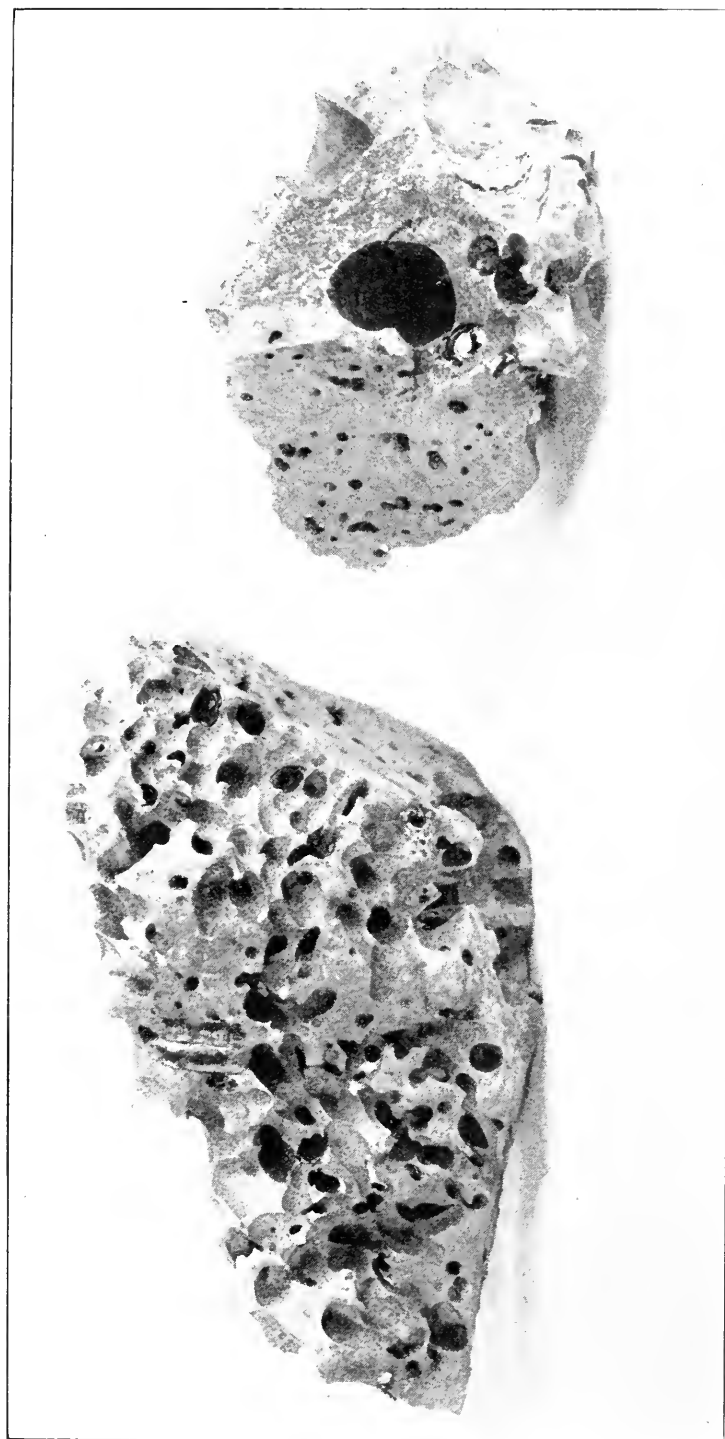
FIG. 17.—SPECIMENS OF STONE FROM RIP-RAP AROUND WEST RIGOLETS LIGHTHOUSE, LA., PERFORATED BY BORERS — *Lithophaga*
(*Dulcerus*) *Bisculata* ORBIGNY AND *Gastrochaena* *Ovata* SOWERBY

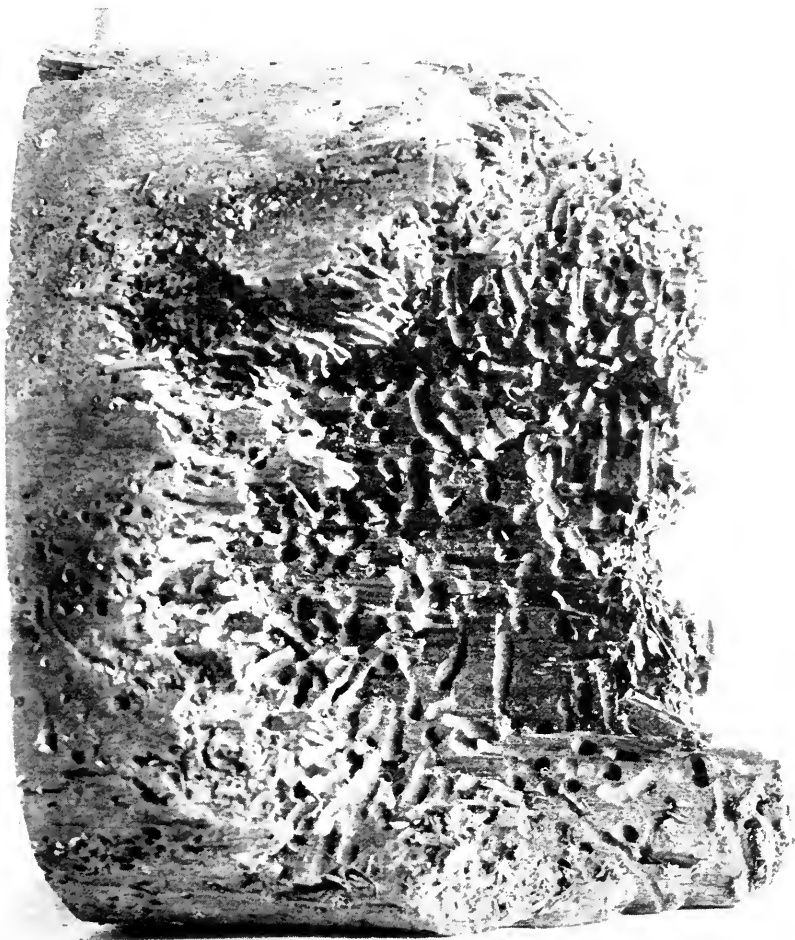
FIG. 19—SECTION OF JUCARO PILE FROM DOLPHIN OF TEXAS OIL COMPANY,
MATANZAS, CUBA

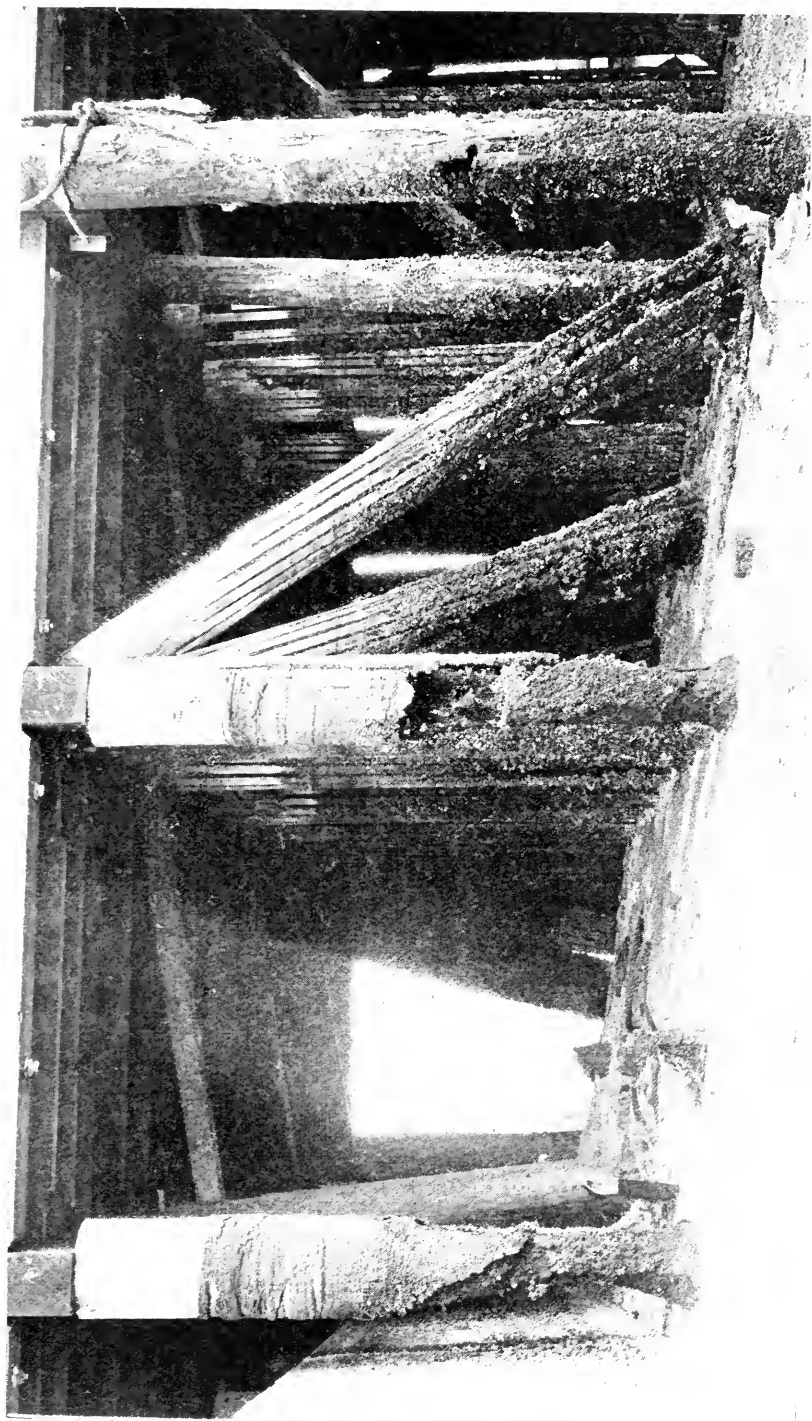
FIG. 21—PERFECTION PILES DRIVEN IN 1903 IN COAL WHARF AT THE PUGET SOUND NAVY YARD.

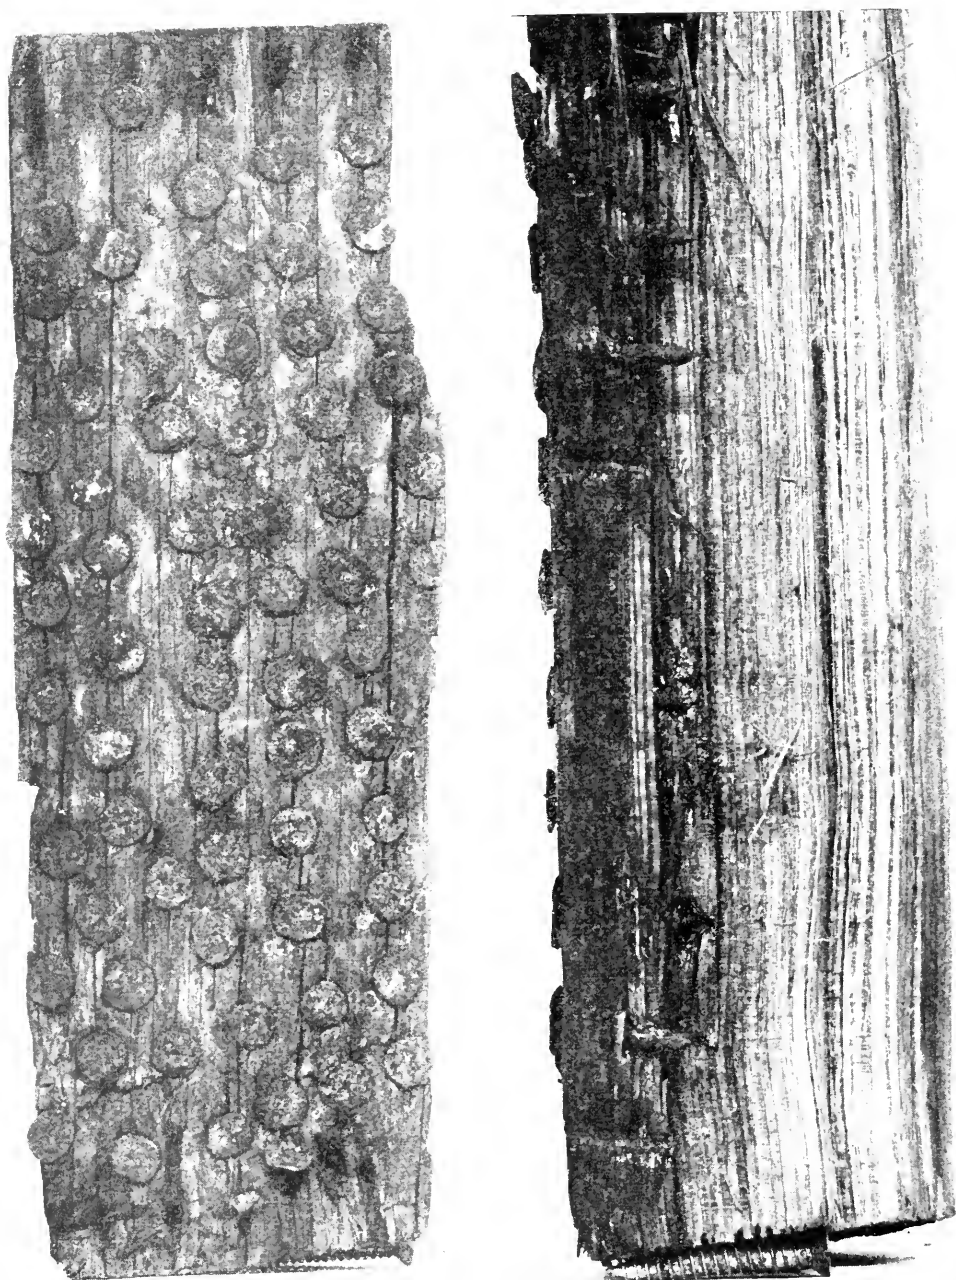
FIG. 22—SECTIONS OF PILE FROM WHARF OF THE CHARLESTON DRY DOCK
AND MACHINE CO., CHARLESTON, S. C., WITH 4 YEARS' SERVICE

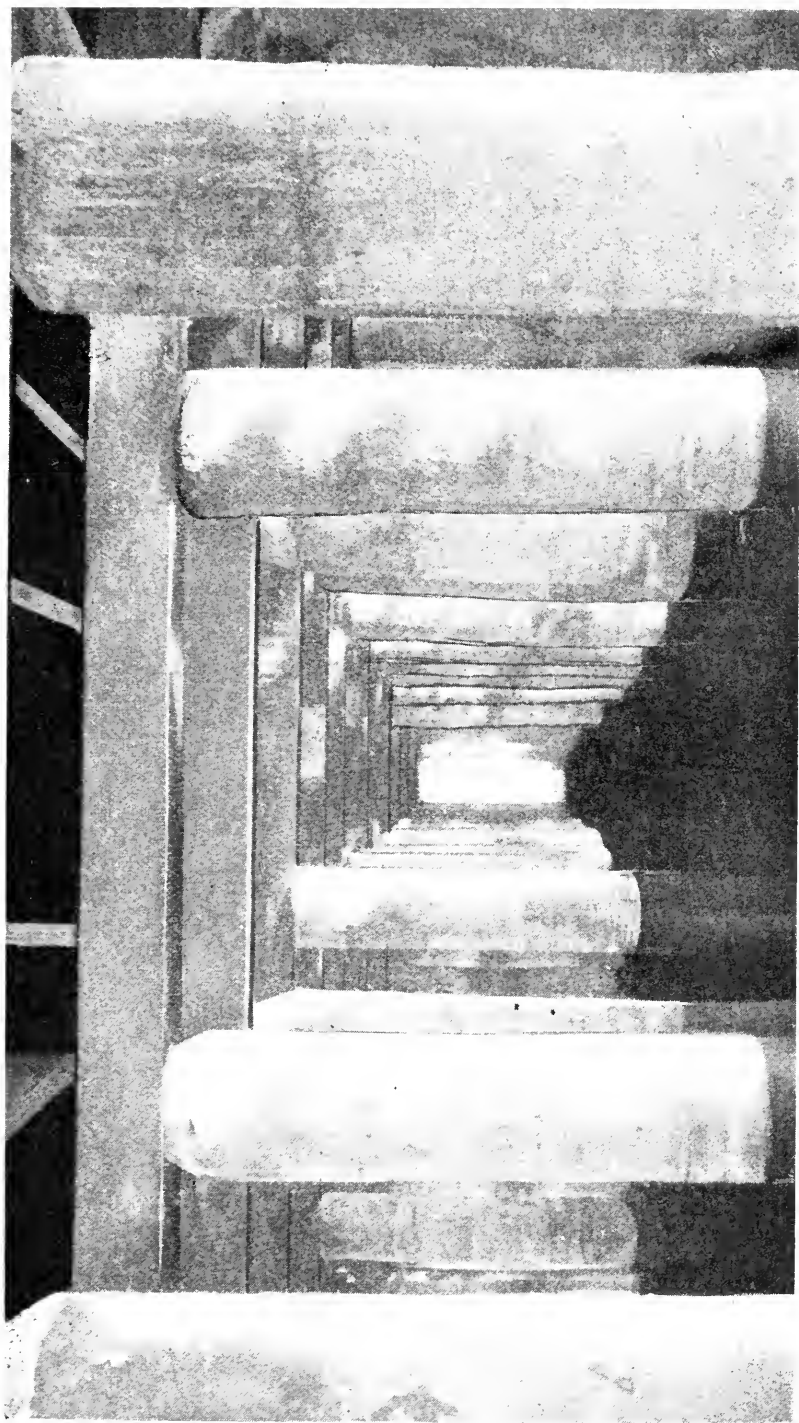
FIG. 23—GUNITE CASINGS ON SHELL OIL CO.'S WHARF, MARTINEZ, CAL.

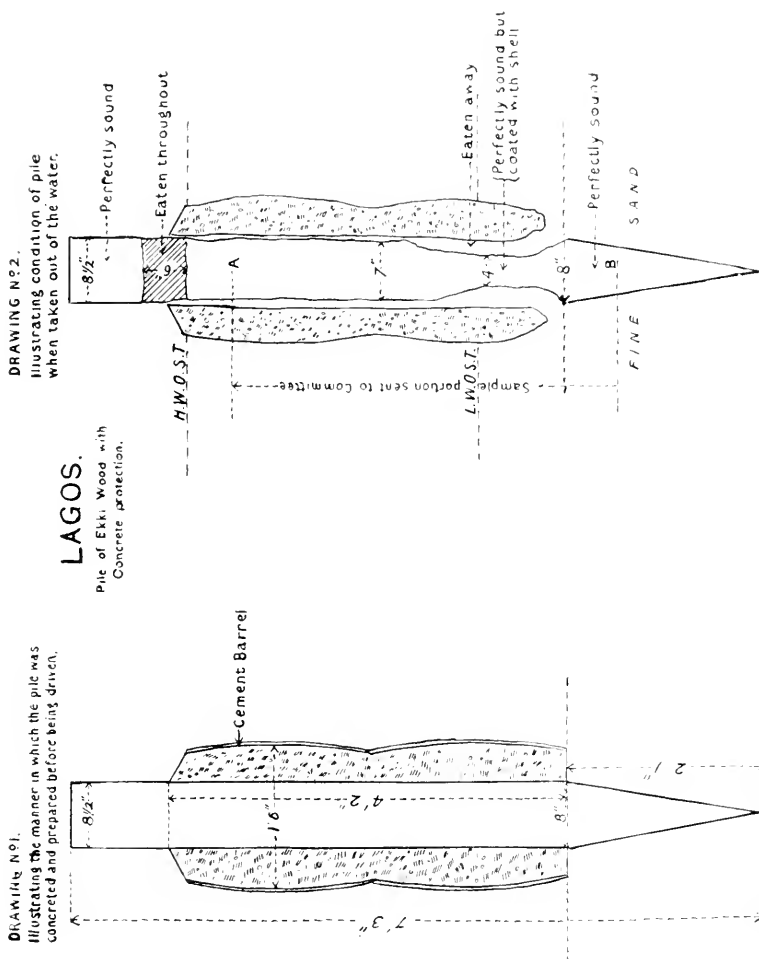
FIG. 25.—SKETCH SHOWING RESULT OF BUILDING CASINGS TOO SHORT.
(REPRODUCED FROM 1ST REPORT, INST. OF CIVIL ENGINEERS)

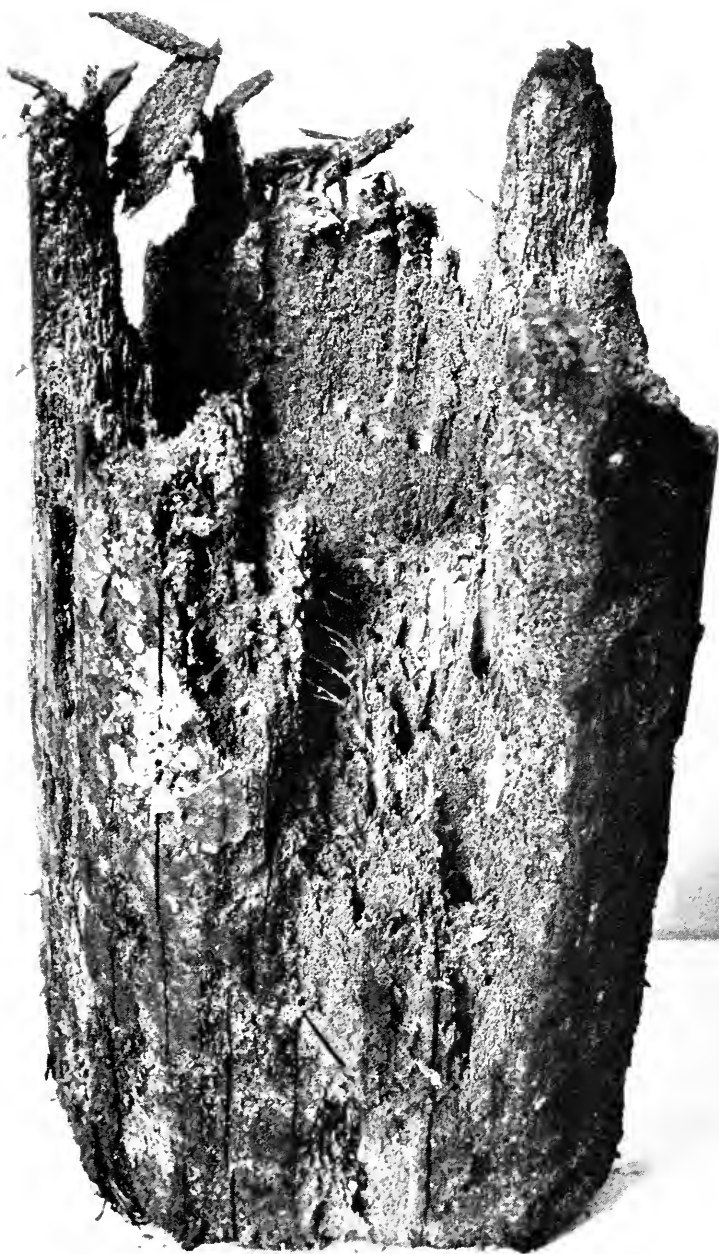
FIG. 27—SECTION FROM CREOSOTED PINE PILE—16 LB. TREATMENT—U. S. NAVAL STATION, ST. THOMAS, V. I.

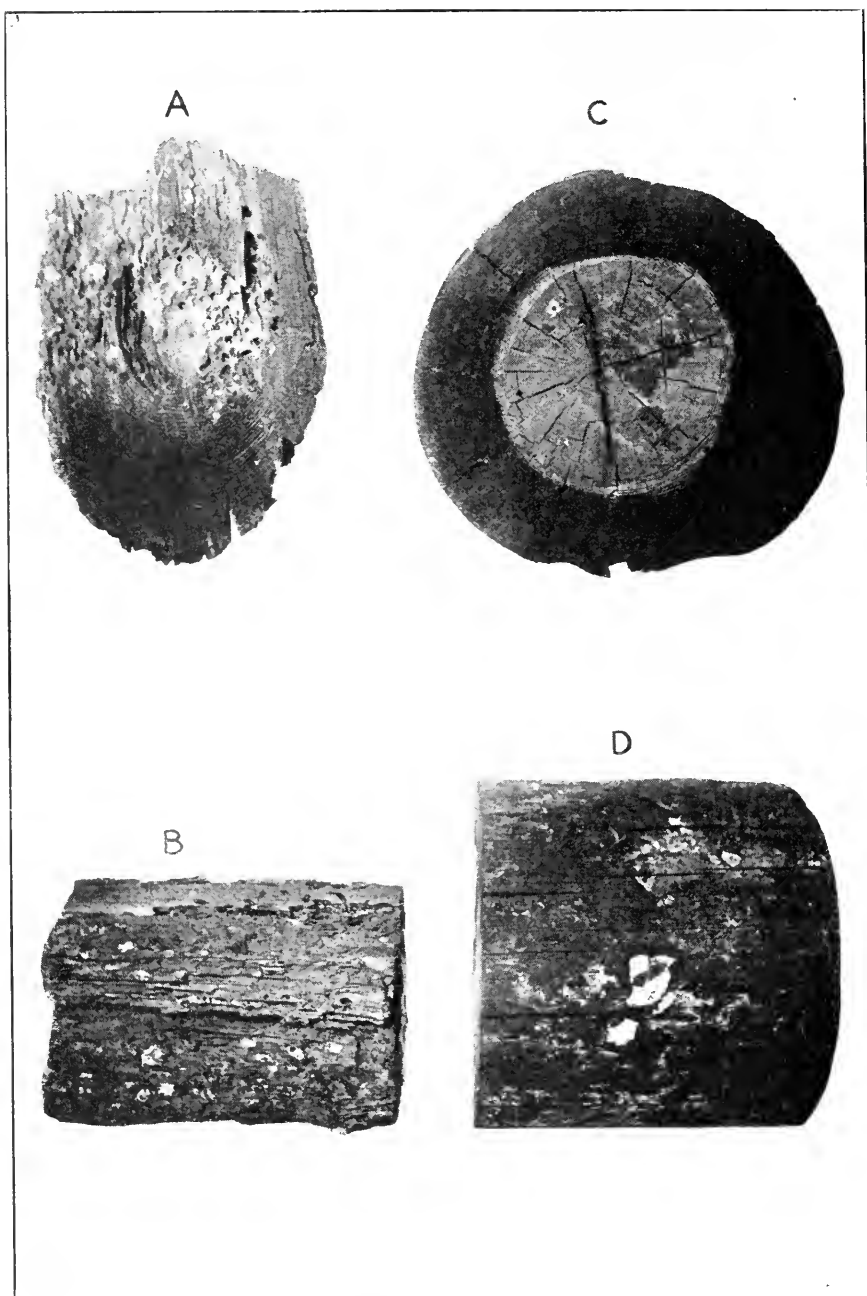
FIG. 30—PILE SECTIONS FROM TURTLE RIVER DOCKS, SOUTHERN RY.,
BRUNSWICK, GA.

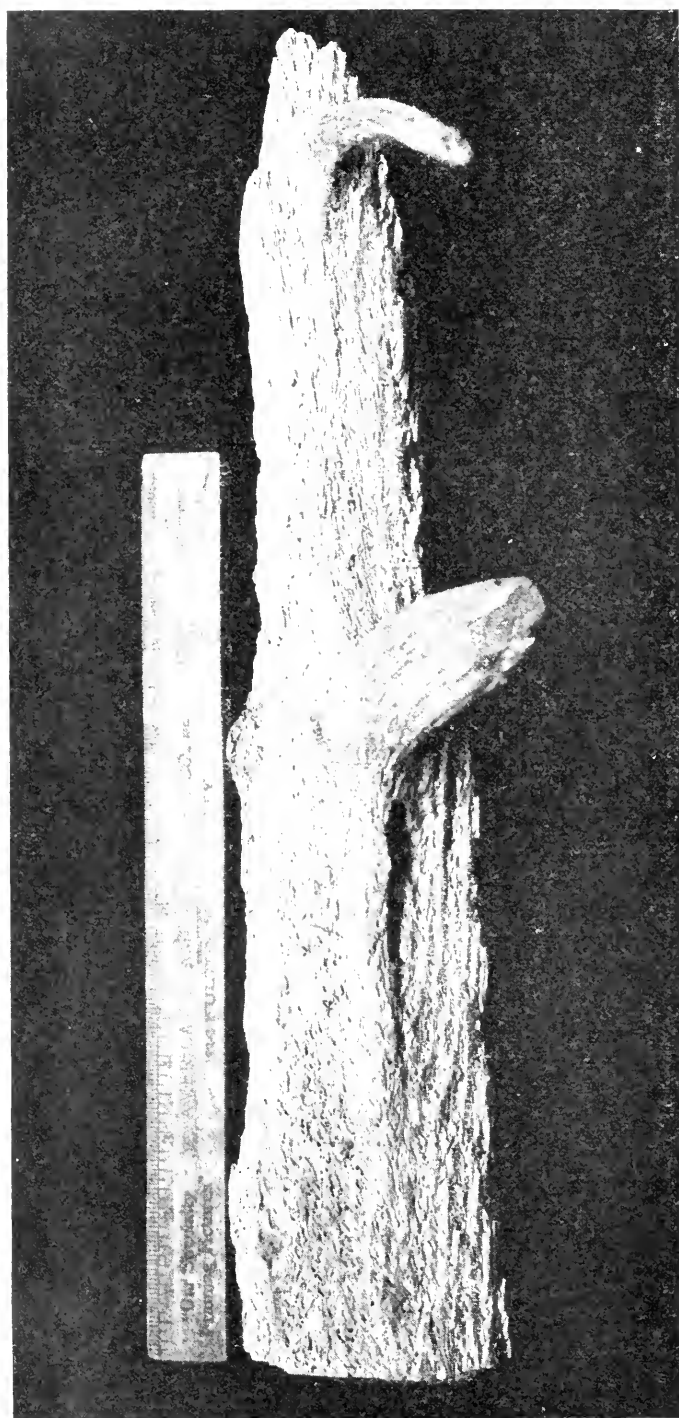
FIG. 42.—SECTION OF PILE DRIVEN IN GRAND TRUNK RT. PIER AT PORTLAND, MAINE, SHOWING *Limnoria* ATTACK. PIER DESTROYED BY BORERS

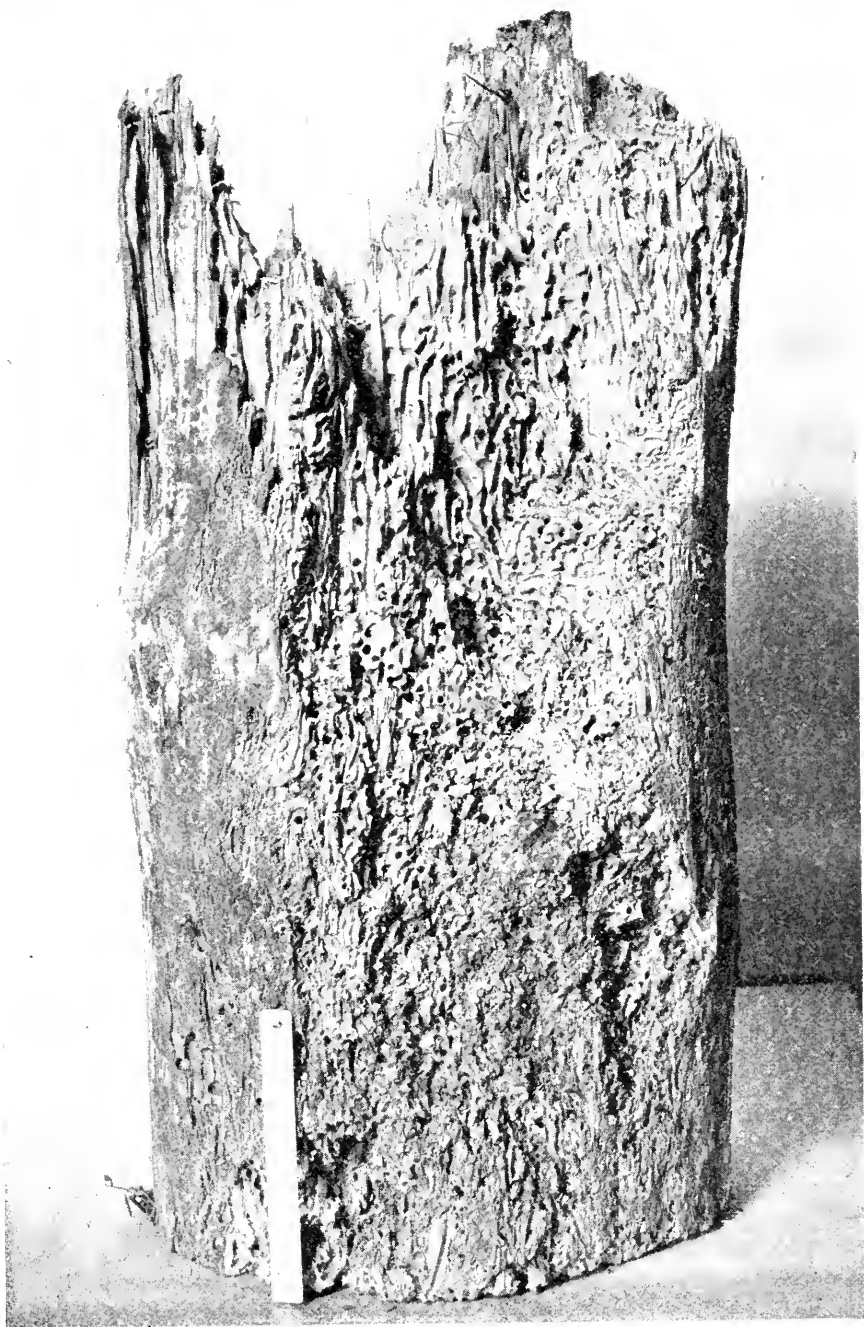
FIG. 64—UNTREATED PINE PILE, U. S. N. SUBMARINE BASE, NEW LONDON, CONN.
Driven, 1918—Removed, 1923.

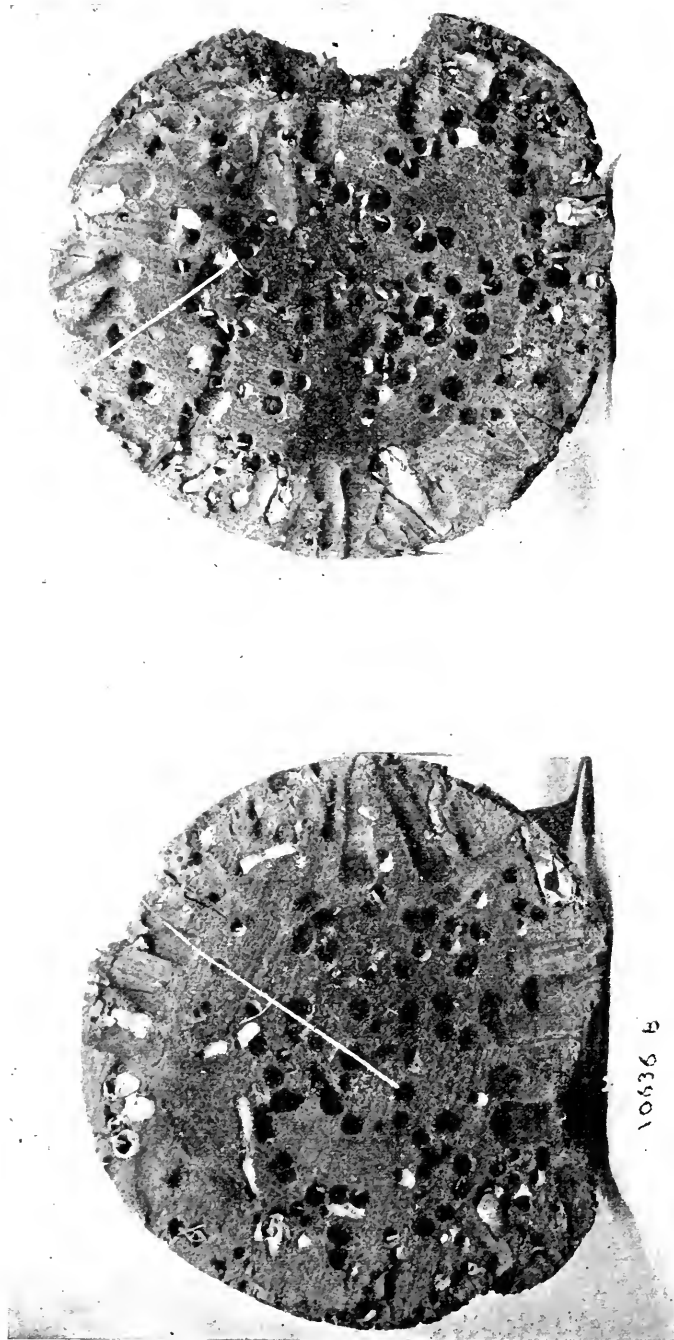
FIG. 114—SECTION OF UNPROTECTED PINE PILE WITH ONE YEAR'S SERVICE AT THE MOUTH OF THE MANATEE RIVER, TAMPA BAY.
ATTACKED BY *Bankia* AND *Martesia*.
